Composite bearings live nearly unnoticed in Florida citrus plant

TOM HUGHES, Managing Editor

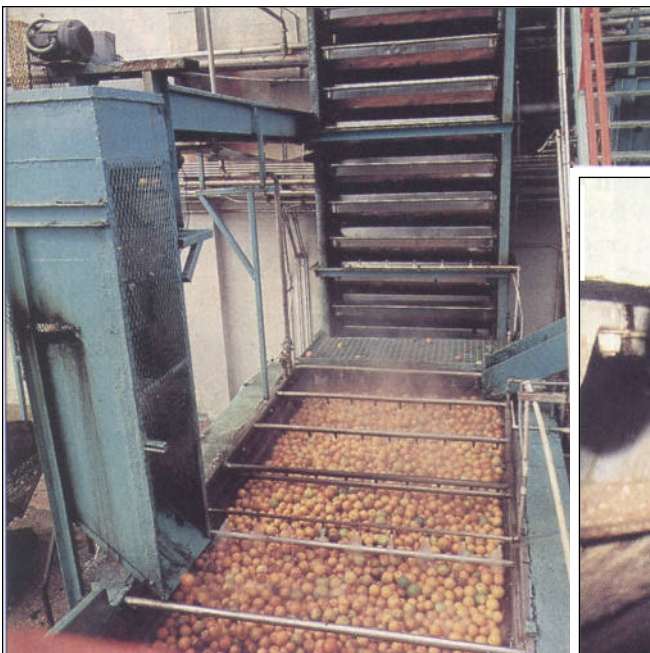
Good for you; not for bearings. As citrus fruit travels on brush-washer conveyor toward elevator, it also gets a sanitizing shower. Brush-shaft bearings down below must take citric acid seepage plus phosphoric-acid shower solution. New composite-housing bearing with double sealing keeps bearings from dying of excessive Vitamin C and cleanliness.

During the 6-month processing season at Caulkins, the two brush washers clean more than 4 million lb of oranges and grapefruit daily. The fruit is transferred from a holding bin via conveyor to the washers, which are outside the plant. The washers move the fruit along to an elevator, which brings it inside for squeezing.

Each washer consists of about 30 long, horizontal shafts which rotate in the same direction and are equipped with brushes. Two bearings, one at either end, support each shaft. The washers clean and convey fruit simultaneously. As the fruit rides along toward the elevator, spray heads above the washers release a sanitizing shower composed of phosphoric acid and water. As the brushes rotate, they scrub the fruit.

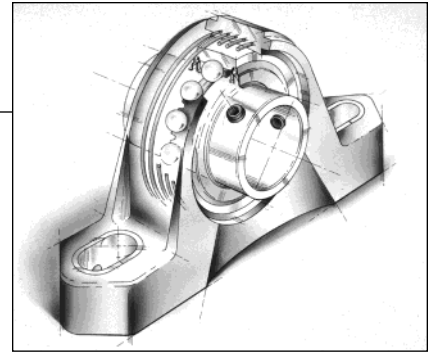
Steel coil molded into housing adds strength and stability. Zinc-coated or black-oxide treated bushing inserts reinforce housing bolt holes. Housing's spherical bore accepts spherical outer ring surface of insert bearing, letting the unit compensate for initial seating alignment errors. Exterior flinger is seal's first line of defense, backed up by rubber lip seals. Space between is filled with grease, and so is bearing. MRC can supply units in 2-bolt pillow-block style, and in 2 and 4-bolt flange units.

Only the composite mounted bearing unit offers substantially longer life. The housing will not chip, peel, or corrode. Also, it is reinforced with an embedded steel coil. As a result, the housing's radial breaking load is three times greater than the insert bearing's static load rating. The coil also provides increased thermal stability, ensuring that the bearing remains firmly seated at steady temperatures to 250 F.

A double-protection seal keeps contaminants from entering the housing and damaging the bearing. One part of the seal, a metallic flinger, is phosphated and coated with phenolic resin. It seals mechanically by producing a centrifugal effect. The second part — low-friction rubber lips — provides an added barrier against process contaminants and washdowns. The insert bearing is lubricated for life with FDA-approved grease.
